## WEB BASED APPLICATION SPECIFIC INSTALLATION INSTRUCTIONS

# Cavity and Pocket Insulation

# Insulating the Frame and Sash Pockets

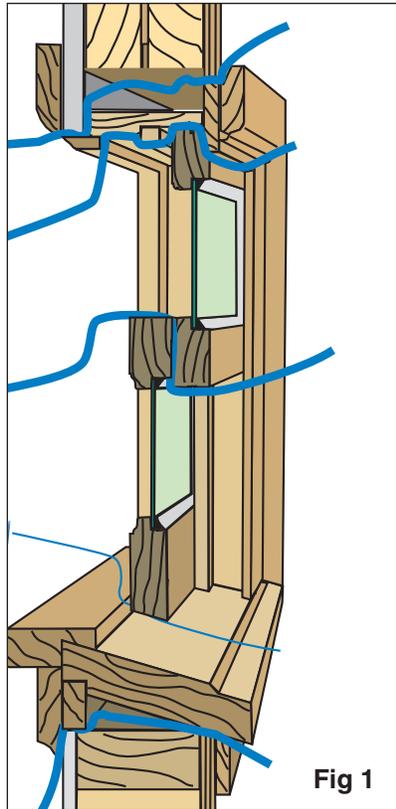
**Fig 1**

**Figure 1:**

Most older windows were installed when energy costs were lower and building codes were not so stringent.

Air could come into the home and heat could escape through joints in the window frame and the rough framing and siding and wall board.

Also leaking air and heat are the joints between the sash and the window frame and the interlock of the sash. Even well weatherstripped windows wear out eventually.

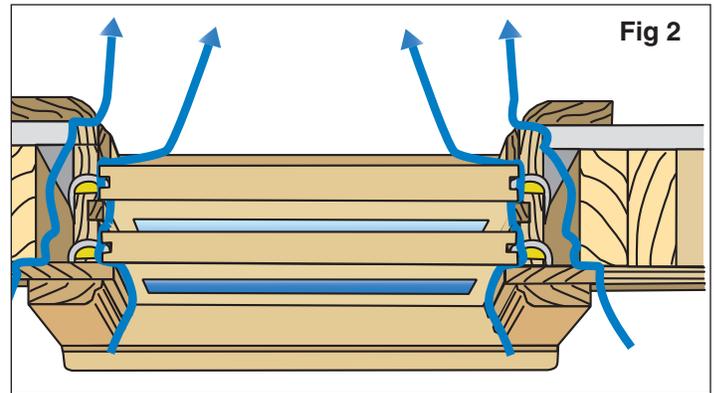
**Fig 2**

**Figure 2:**

Adding to the air leak and heat escape is the lack of insulation in the interior pockets. There are pockets of empty space where the old weights and balances were hidden, and between the tapered sill and the flat rough sill, and above the window header — as well as the side jamb cavities.

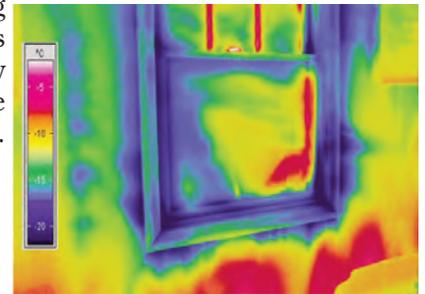
Thermal imaging shows the heat loss through the window and through the frame around the window.

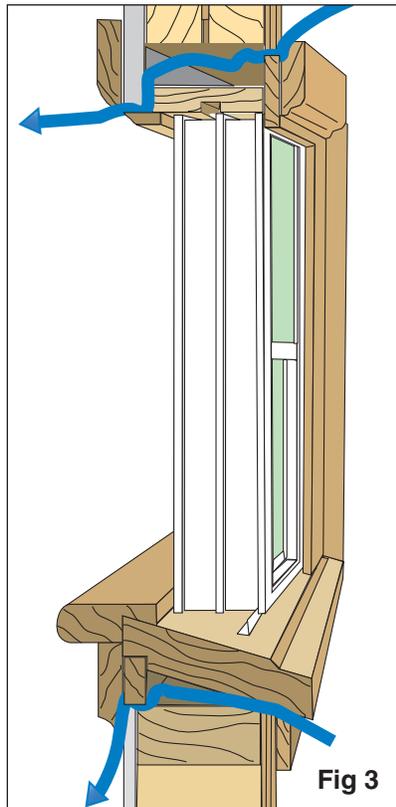
**Fig 3**

**Figure 3:**

Modern Replacement Windows have tighter tolerances in the weatherstripping and at the interlocks. This better design and construction cures most of the window caused air and heat transfers because the gaps have been closed.

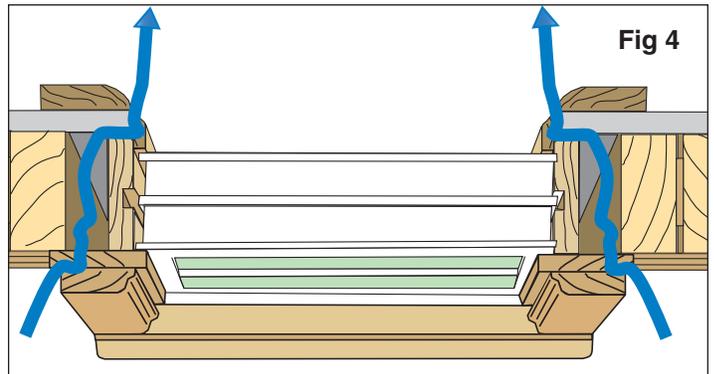
**Fig 4**

**Figure 4:**

Too often the new window is fit to the left-in-place old window frame without insulation in the weight/balance pockets, below the sill and above the header - or in the jamb cavities. This leaves significant drafts, heat loss and dissatisfaction of the new windows. Thermal images show the cold around the new window even though the window itself is “warmer”.

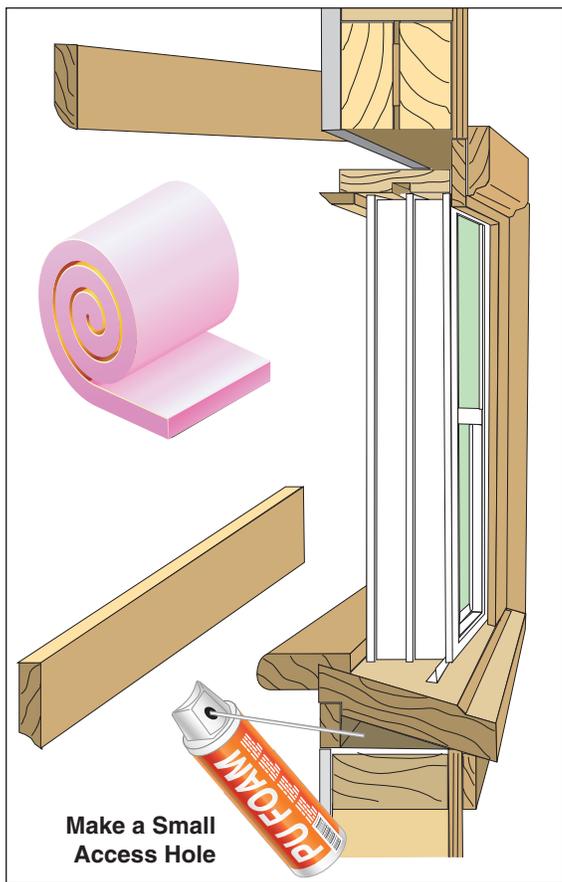
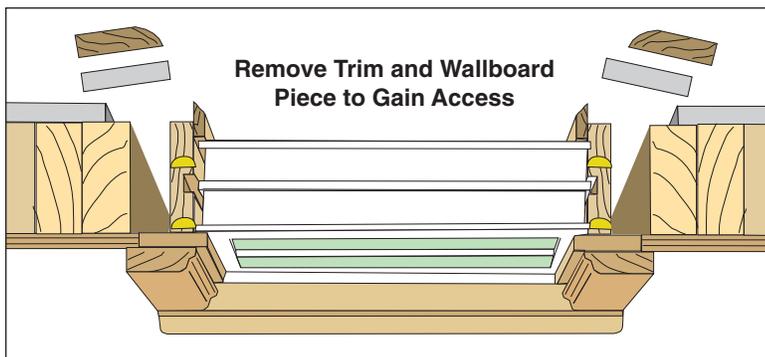
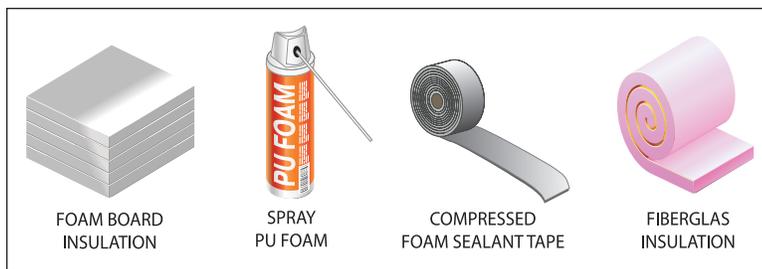
There are a number of choices to insulate inside the cavities between the old window frame and the rough framing.

Spray PU Foam is the easiest because it doesn't require full removal of the trim if the nozzle can be inserted into the gap.

However, Spray PU Foam expands and you must be careful not to have it expand to where it deforms the window and wall parts.

Foam board needs to be cut precisely, while fiberglass batts can be inserted more easily.

Compressed foam conforms to the contours between the rough opening and the new window, best.

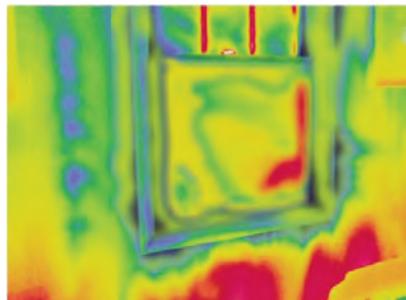
Thermal Images of fully insulated gaps, using any of a variety of material choices, demonstrate that the total opening will block air infiltration and heat loss as well as the new window.
